Manhole Inspection Summary

Manhole # S23KK1002MH

Insp Date: **11/20/06 2:04 PM**

Location Address: **4300 BUCHANAN AVE**

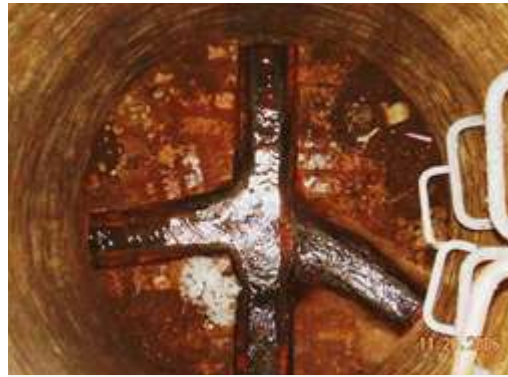
Top View

Barrel infiltration. Evidence of surcharge - Bench debris.

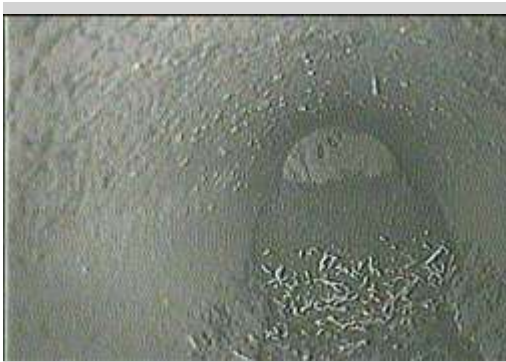
Inside the I6

Plugged.

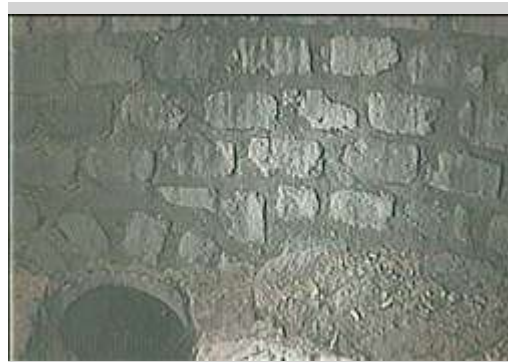
Defect

Infiltration: ☐ None ☐ Joint ☐ Cracks ☒ **Mortar** ☐ Roots ☒ **Wall**

☒ **Evidence Of Surcharge**

Depth: **3** (ft.) ☐ Active Surcharge Present

Barrel infiltration. Evidence of surcharge - Bench debris.

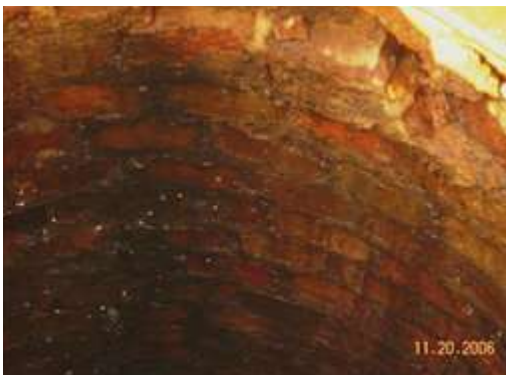
Defect

☒ **Leaks**

Condition: ☐ Sound ☐ Cracked ☐ Root Intrusion ☐ Loose Brick ☒ **Deteriorated**

Infiltration: ☐ None ☒ **Joint** ☐ Cracks ☒ **Mortar** ☐ Roots ☐ Wall

Frame leaks. Adjustment deterioration and infiltration.

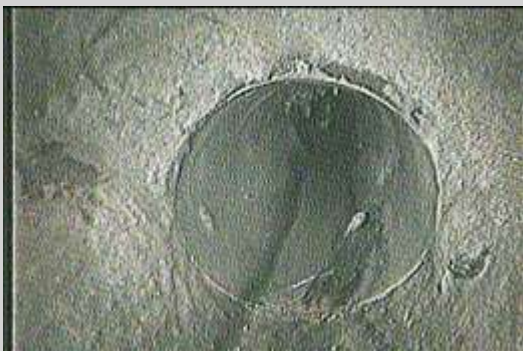
8 in. Circular Gravity Sewer Pipe In @ 4 O'Clock

Infiltration: **Evidence** Pipe Seal Cond: **Unknown**

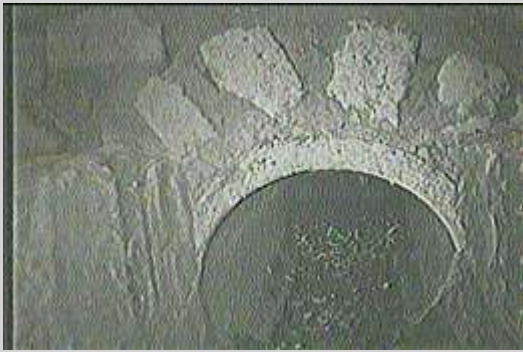
8 in. Circular Gravity Sewer

Deposits: ☐ None ☐ Mud ☐ Sludge ☒ **Debris** ☐ Grease

Silt Depth: **0.5** (in.) Deposits Extent: **Light**

Connects To: **Stub connection / abandoned**
